Spy Glass Home Inspections, Long Island

Property Inspection Report

Inspection prepared for: Sample Sample
Date of Inspection: 10/2/2013 Time: 10:00 AM
Age of Home: xx Size: xx
Weather: Sunny

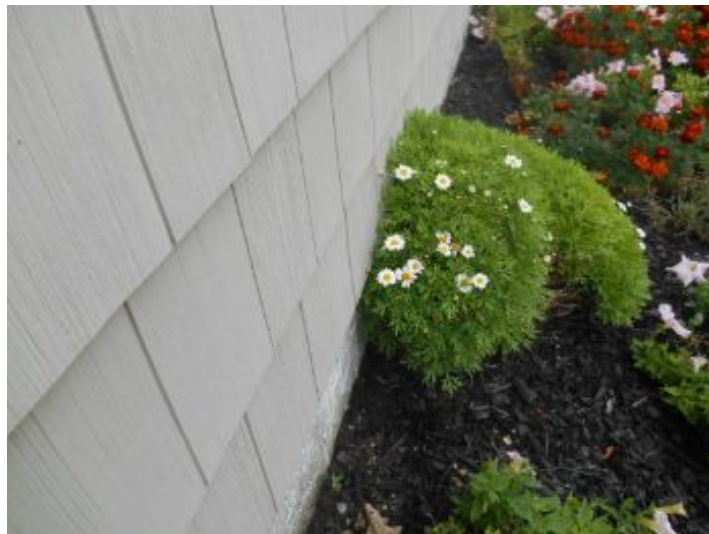
- Prune or remove any plants that are in contact or within 10" of home to eliminate pathways of wood destroying insects.

Prune or remove any plants that are in contact or within 10" of home to eliminate pathways of wood destroying insects.

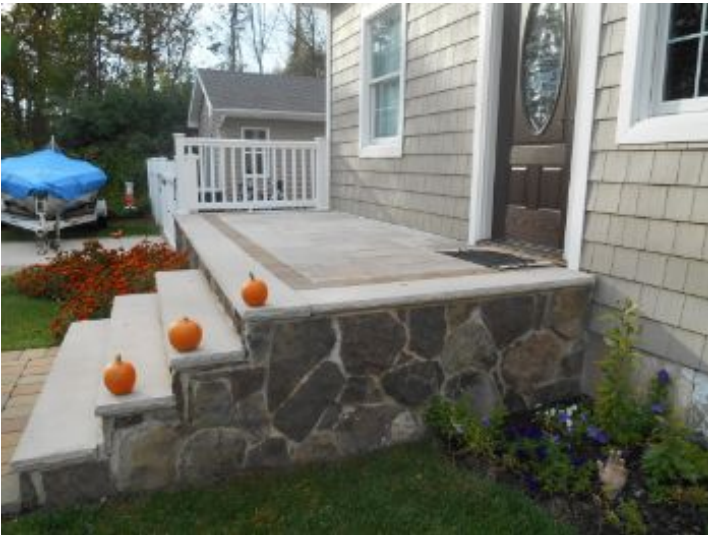
- Rails missing at exterior steps, and should be installed for safety.

No handrails noted, safety concern. Recommend placing hand rails.

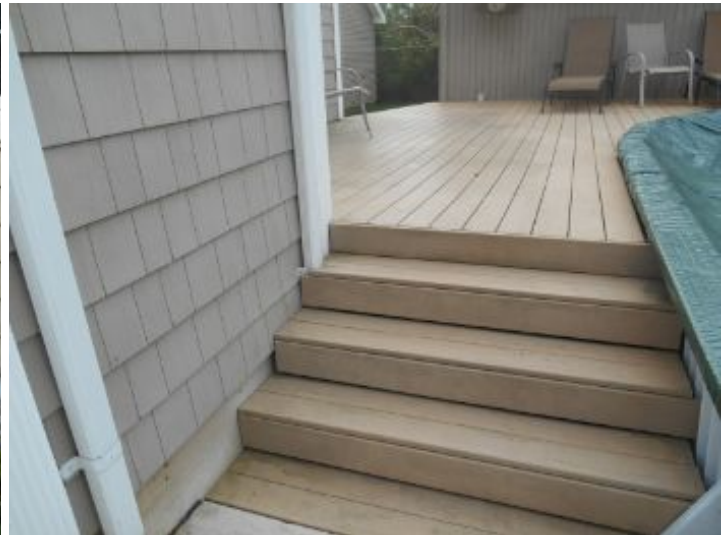
Missing handrails. Rec. handrail installation. Safety concern.

- There are no handrails on stairs of deck. Recommend having railings installed as this is a safety issue.

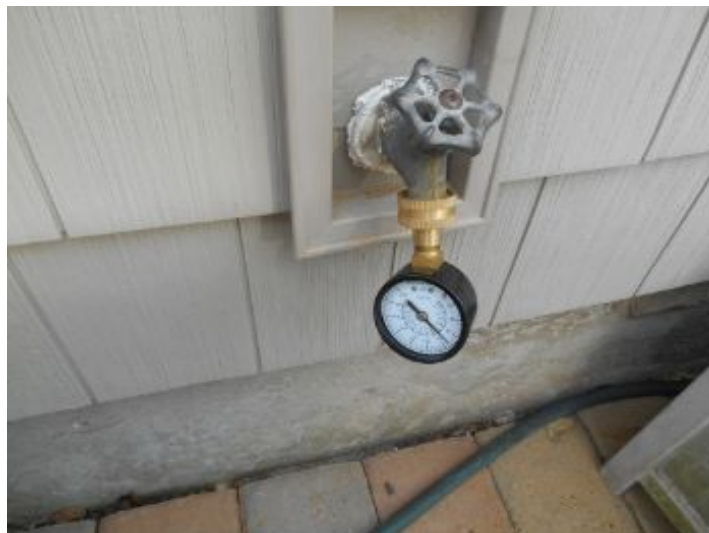
- 70 PSI

70 psi hose bib is not frost free

-
- Not frost free.
- **Recommend upgrading to a frost proof type hose bibb to prevent possible damage due to cracking of water line in below freezing temperatures.**

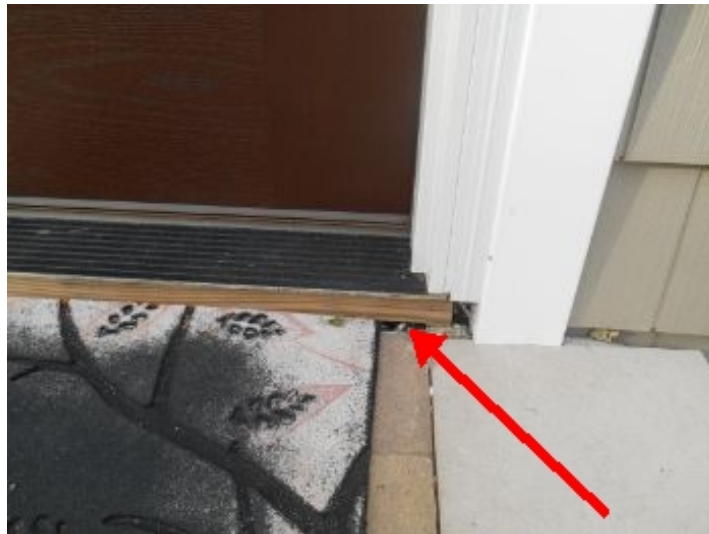
- Front door entrance missing flashing under sill.

Front door sill missing flashing. Will lead to water infiltration. Rec. licensed contractor.

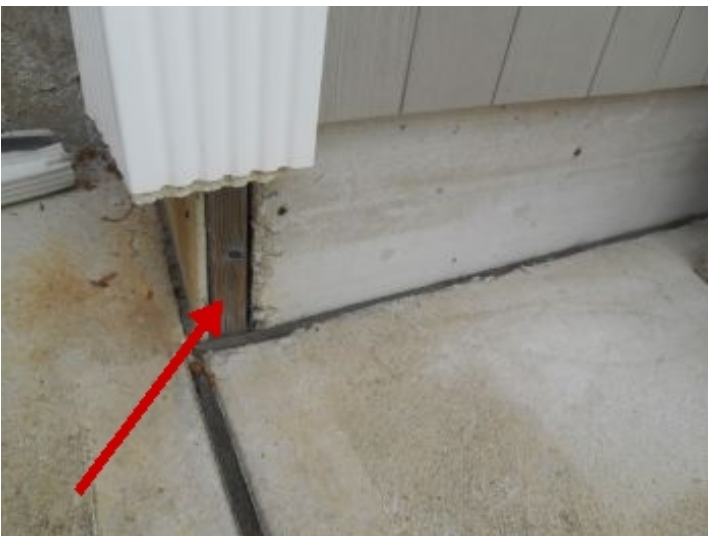
Exposed framing, can lead to water infiltration & wood rot. Rec. licensed contractor.

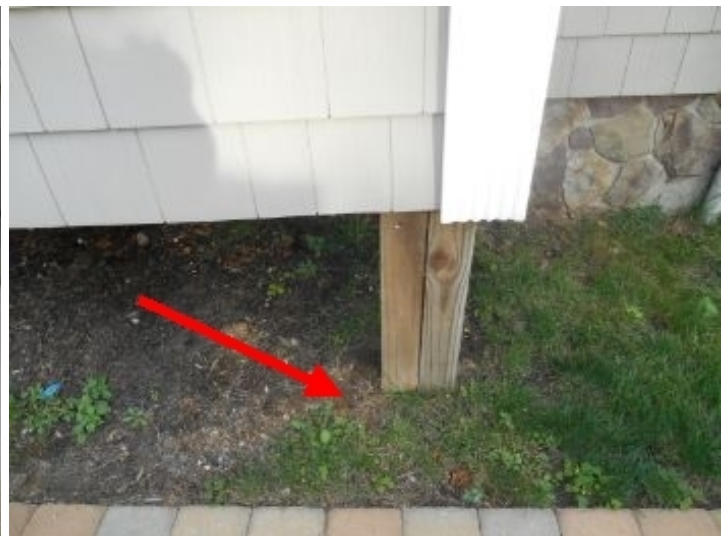
4x4 wood support in contact with ground, this can lead to wood rot & pest infestation. Rec. licensed contractor to fix.

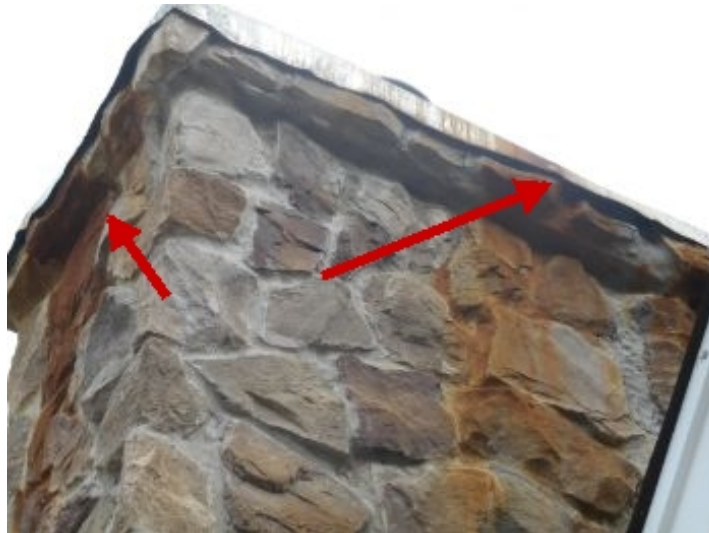
Observations:
 • Recommend level 2 inspection of chimney. Flashing damaged water stains on stone veneer.

Recommend level 2 inspection of chimney. Flashing damaged water stains on stone veneer.

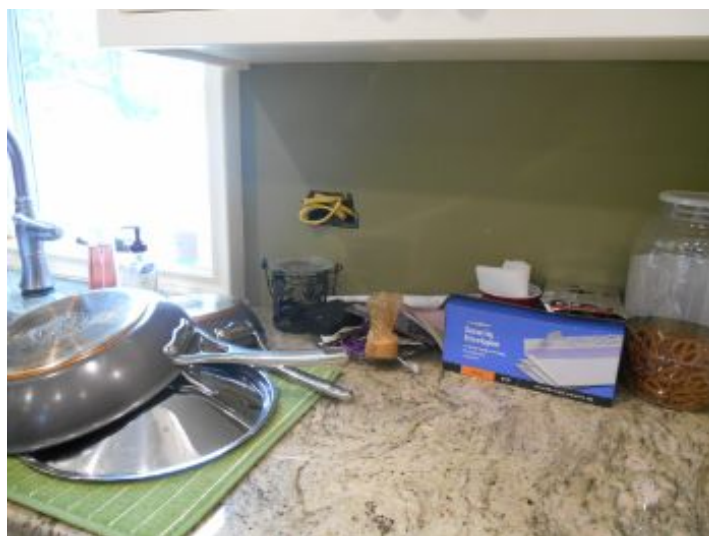
Observations:
 • **Backsplash in kitchen is not installed. There are open electrical boxes with missing outlets, (2) GFCI outlets in place, missing covers.**

Backsplash in kitchen is not installed. There are open electrical boxes with missing outlets, (2) GFCI outlets in place, missing covers.

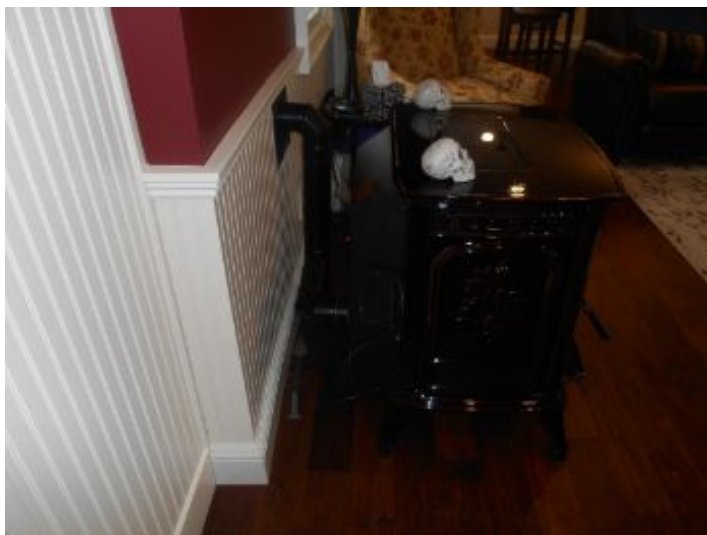
Materials: Cast iron pellet stove in place.

Pellet stove

- Level II inspection—The National Fire Protection Association (www.nfpa.org) advises that each chimney receive a Level II inspection each time a residence is sold. Inspection levels are explained at www.csia.org/pressroom/press-inspection-levels-explained.htm. It is also advised that this inspection be conducted by a chimney sweep certified by the Chimney Safety Institute of America (www.csia.org).

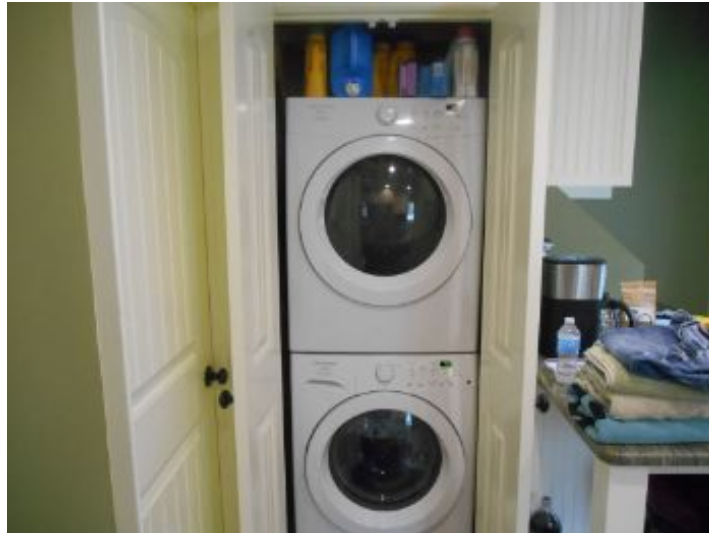
• Could not fully inspect the dryer vent, it is obscured. Vents to the outside of home, aluminum vent can be seen through exterior vent. But cannot see entire length.

Could not fully inspect the dryer vent, it is obscured. Vents to the outside of home, aluminum vent can be seen through exterior vent. But cannot see entire length.

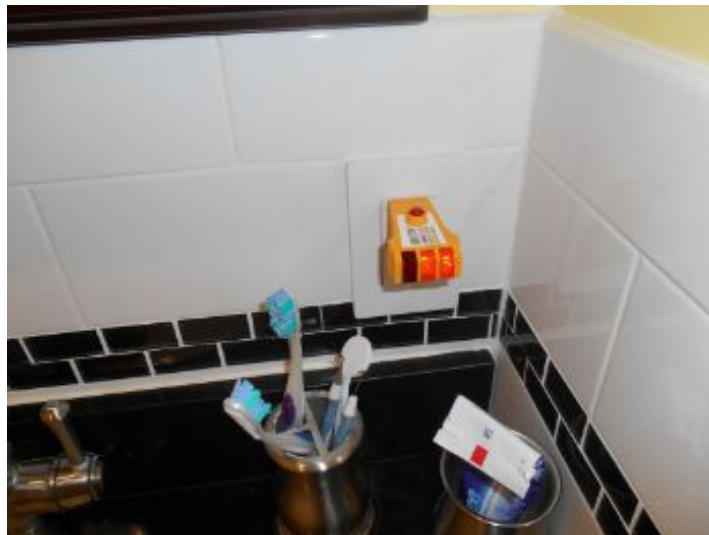
GFCI good

Observations:
• GFCI in place and operational

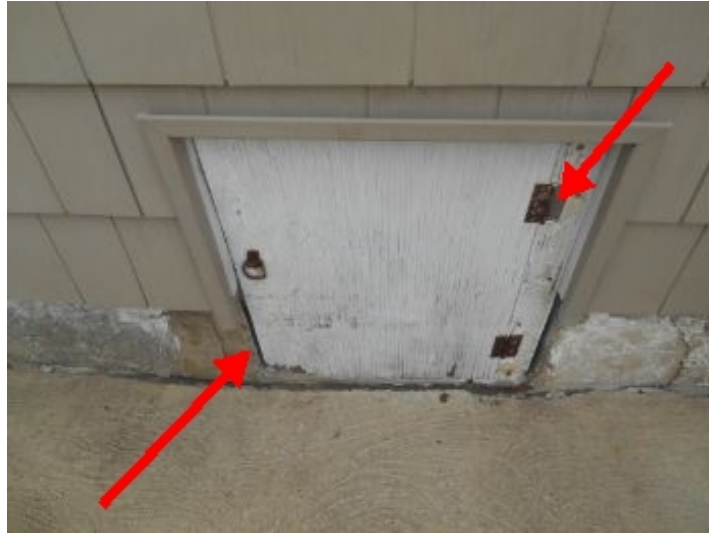
- Access door and frame have wood rot hinges are loose.

Access door, hinges loose, door & frame with wood rot. Rec. licensed contractor to replace.

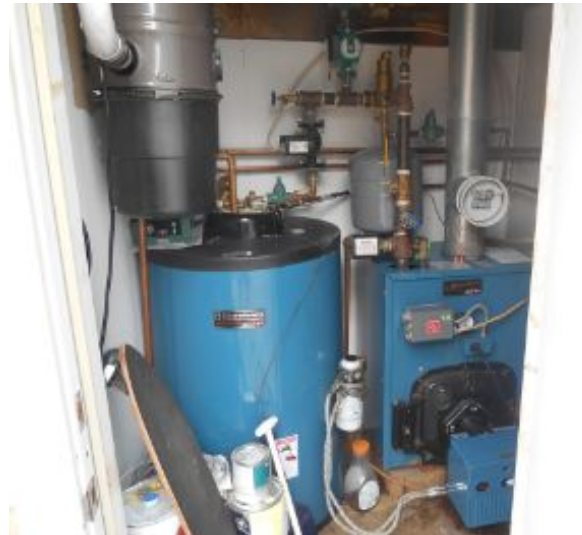
Materials: The boiler is located in the utility room.

Utility room with boiler, water heater & central vac unit.

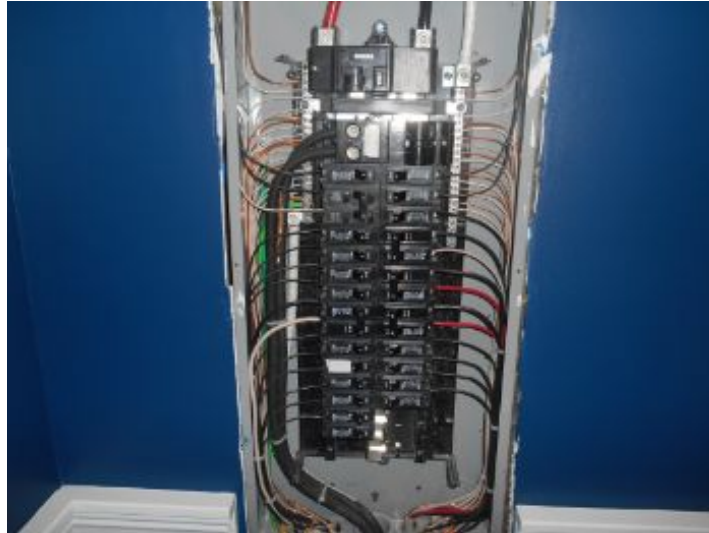
Main panel

Observations:
• 200 amp

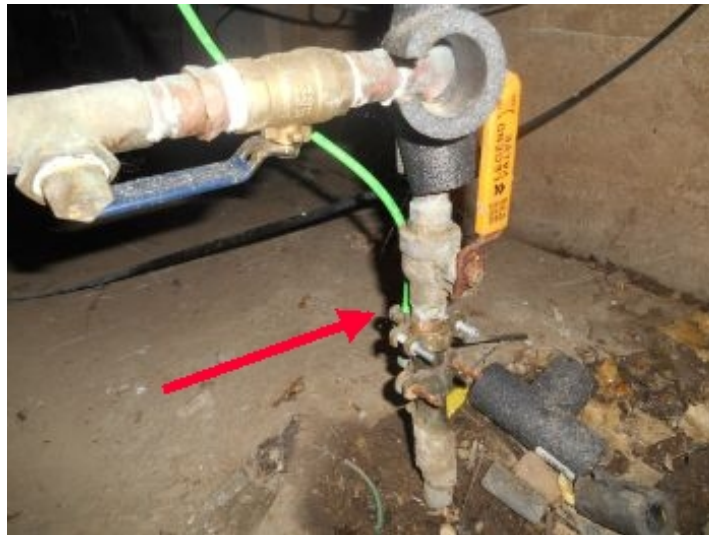
3/4" copper grounded
